**AFRL-ML-WP-TR-2003-4170**

**NONDESTRUCTIVE INSPECTION (NDI)  
THROUGH HIGH-VELOCITY OXYGEN  
FUEL (HVOF) THERMAL SPRAY  
COATINGS**

**Delivery Order 0001: Nondestructive Evaluation  
Exploratory Development for Air Force Systems**

**Interim Report for 01 August 2001 – 30 May 2002**

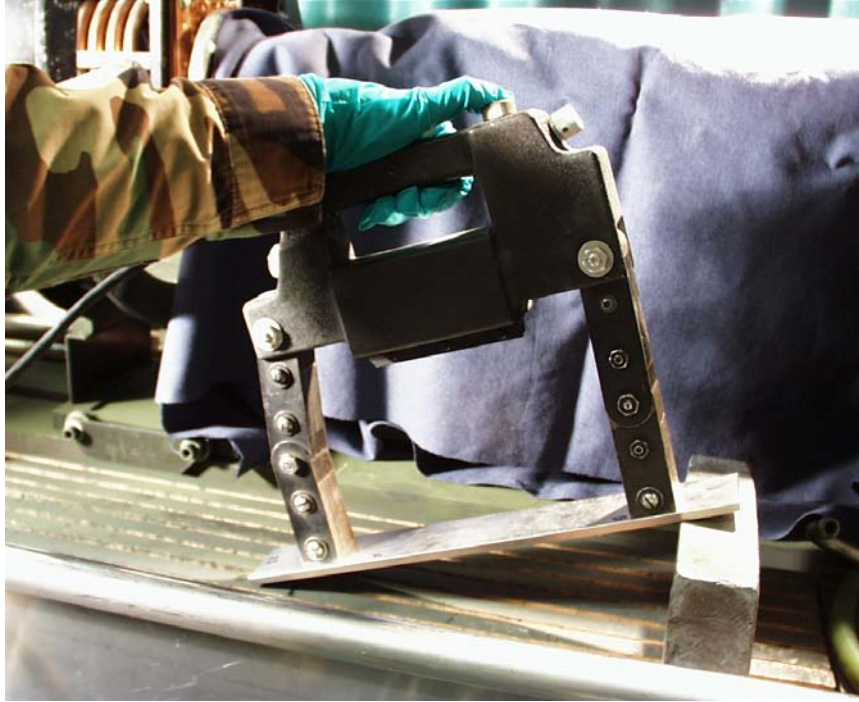
**Figure 2a. Magnetic particle inspection using Parker Probe.**

flat against the specimen approximately one inch from each end. The Parker Probe was set on AC and the highest level of magnetizing power. The probe was used to magnetize the specimen for approximately 6 seconds. Magnetic particle suspension was then immediately poured over the specimen. The specimen was then immediately magnetized for an additional 8 seconds (see Figures 2a and 2b). Next, the specimen was propped up nearly vertical allowing the magnetic particle suspension to continue to flow perpendicular to the cracks. This facilitated an optimum accumulation of fluorescent particles at crack sites. A specimen was allowed to drain for approximately 30 seconds. Then the specimen was inspected under an ultraviolet light (UV-A) (see Figure 3). After identifying the cracks, digital pictures of the fluorescent indications were obtained. The pictures were downloaded into an image processing software enabling the measurement of the indication lengths (see Figure 3).

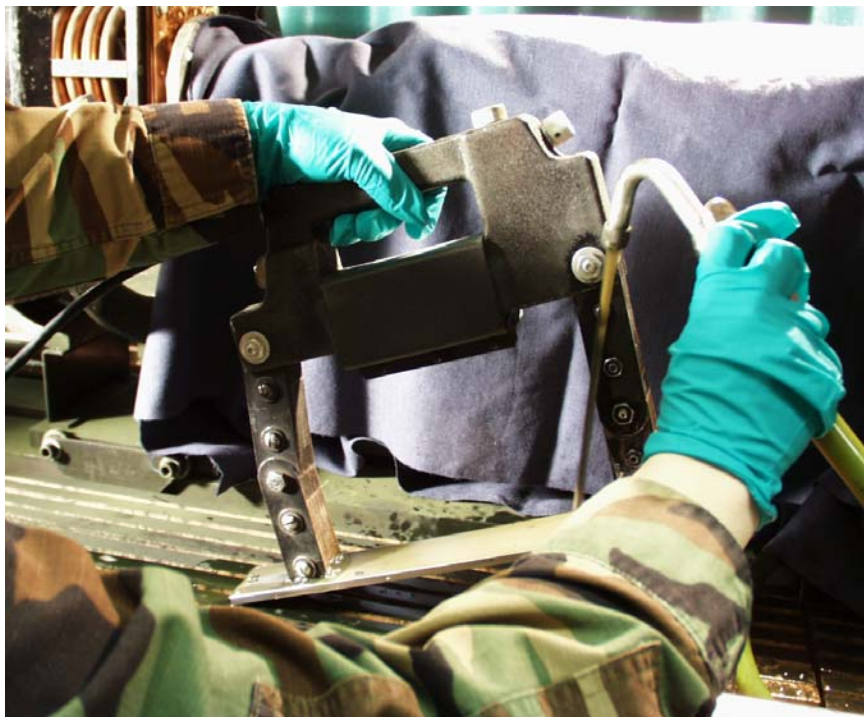
**Figure 2b. Magnetic particle bath being poured onto specimen.**

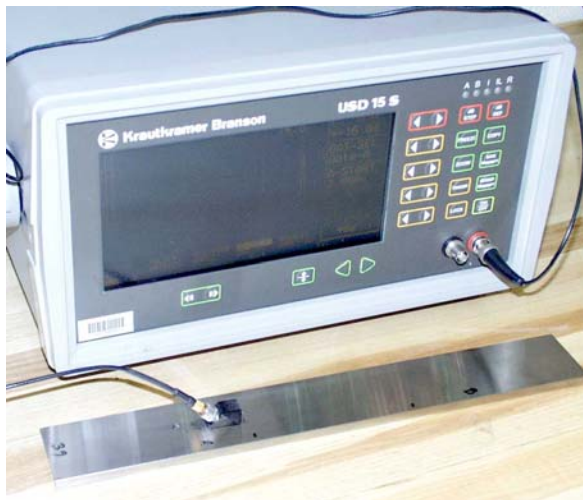
**Figure 4a. Ultrasonic inspection setup.**

Before the specimens were coated, a manual ultrasonic pulse-echo, shear-wave technique was developed with a Krautkramer Model 15S ultrasonic instrument and a Krautkramer KB-A (part number 90289) ¼ inch, 10 MHz transducer. The transducer was attached to a plastic wedge in order to produce a shear-wave ultrasonic beam in a specimen at a 60-degree angle (with respect to a line perpendicular to the surface of the specimen). The transducer was placed on the same surface as a crack so that the sound beam bounced off the opposite surface back towards the crack. The transducer was scanned and rotated by hand until the amplitude of the reflected signal from the crack was maximized. Figure 4a depicts the ultrasonic equipment and setup. Figure 4b shows a close-up of the ultrasonic probe. Figure 4c is a picture of an ultrasonic response.

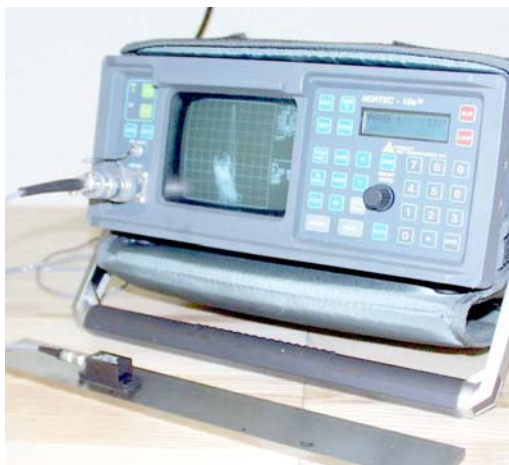
**Figure 5a. Eddy current inspection setup.**

A manual eddy current technique was developed with a Nortec 19e<sup>II</sup> instrument and a Nortec absolute probe (part number 972511) with a frequency range of 100 to 500 kHz. The instrument was set to operate at 200 kHz. The probe was inserted into a holder to maintain its orientation perpendicular to the inspection surface. The probe was scanned by hand until a crack signal was maximized. Figure 5a depicts the eddy current inspection setup. In order to reduce the effects of variable permeability on the eddy current signals, each specimen was first magnetized with the Parker Probe set to apply direct-current magnetization.
